THE ROLE OF MATERIALS DEGRADATION AND ANALYSIS IN THE SPACE SHUTTLE COLUMBIA ACCIDENT INVESTIGATION

Steve McDanel, NASA, Kennedy Space Center, Florida, USA

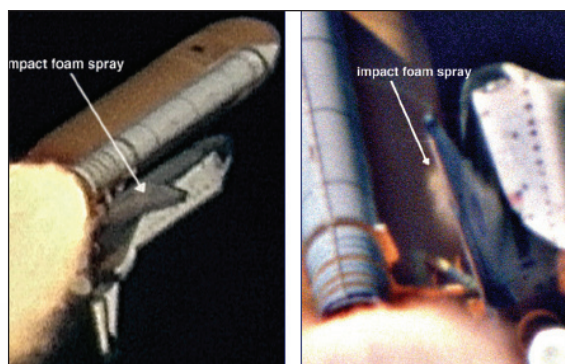
Figure 2. Foam impacting left wing of Columbia during ascent

A review of high resolution still and video imagery recorded during the launch indicated that a piece of foam from the External Tank struck the underside of the left wing during ascent (Figure 2).

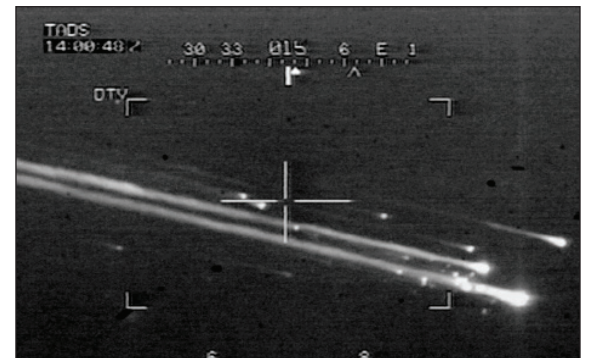
The last communication from the Columbia took place during re-entry, at 8:59:32 a.m. (EST), on February 1, 2003; by 9:00:18 a.m. (EST) the Orbiter had begun to disintegrate (Figure 3). Because the Columbia was travelling in excess of Mach 18 at an altitude of approximately 63,400 m (208,000 ft) when she began to break apart, the resultant debris field was nearly 1,030 km long by 16 km wide (640 miles long by 10 miles wide). Approximately 84,000 pieces of debris were eventually collected, weighing nearly 38,555 kg (85,000 lb), corresponding to roughly 38% of the Orbiter's dry weight.

Figure 3. Danish AH-64 helicopter photo of the Columbia disintegrating

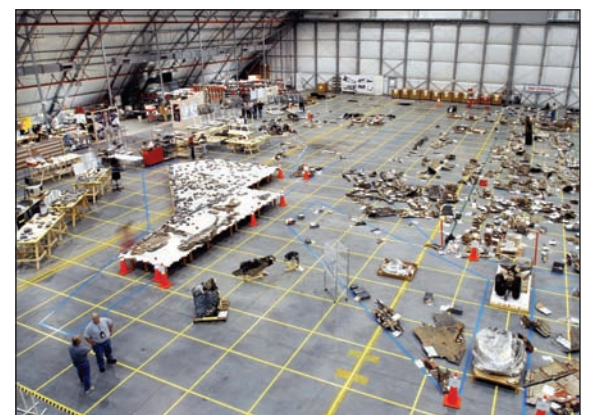
The debris which was recovered was then delivered to the Kennedy Space Center (Figure 4). There, the remnants were further identified and evaluated, and pieces from primary areas of interest were placed in a reconstruction hangar, where an outline of the Orbiter had been superimposed on a floor grid to facilitate the reconstruction process.

Figure 4. Reconstruction of the Columbia debris at the Kennedy Space Center

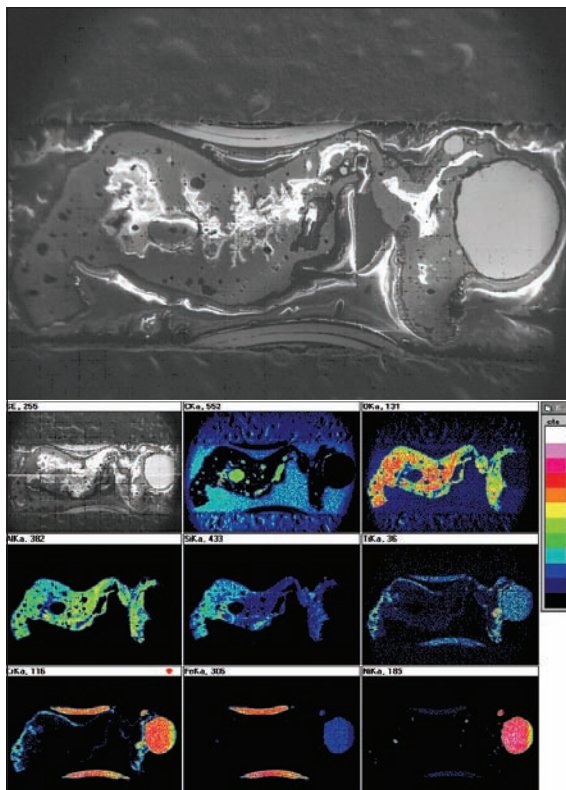
ESCA/XPS and XRD were beneficial in determining compounds which were found in the deposits. EPMA and SEM/EDS were useful in understanding and characterising the sequence and ordering of the deposits (Figure 5). Specific alloys could be identified by their respective ratios of nickel and iron, which, along with the presence of alloying elements such as molybdenum, cobalt, niobium, and titanium, helped differentiate and identify alloys such as Inconel 601, Inconel 625, Inconel 718, and A286.

Figure 5. Materialographic cross section of deposit (top) and X-ray dot map (bottom)

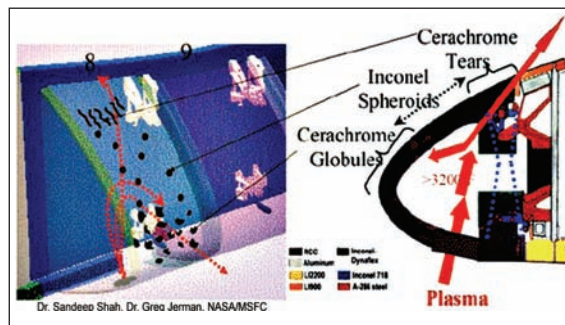
The combination of the recovery location (further west versus east), chemical analysis, and damage evaluation helped the investigators determine that the likely location where a breach occurred was in the outboard region of left wing RCC panel 8. The RCC fragments from this area displayed the most severe "knife-edge" attack, indicating they were exposed to the plasma stream for the longest duration. Based upon the presence of melted cerachrome, a ceramic insulating material used inside the structure of the wings of the Orbiter, it was estimated that the temperatures encountered during re-entry were in excess of 1760° C (3200° F). The lack of A286, and the presence of Inconel 601, in the initial layers of deposits indicated that the breach occurred lower on the RCC panel rather than in the upper region, corresponding to the video and photographic evidence obtained during the launch.

The information evidenced by the debris was also crucial in ascertaining the path of impinging plasma flow once it had breached the wing (Figure 6). As the plasma began penetrating the leading edge panels, the Inconel 601 foil-covered cerachrome insulation blankets began to melt and vaporise within the wing. Hardware adjacent to the RCC panel 8 region, including wing carrier panel tiles directly aft of the breach, began to slump and melt. Hardware, including adjacent RCC panels, began to erode downstream of the breach. This type of damage was not observed on panels upstream, or inboard, of the suspected breach location in panel 8. Eventually A286 and Inconel 718 leading edge attach hardware began to melt and weaken in the path of the plasma flow. Ultimately, the impinging plume compromised the wing leading edge spar, whereby the left wing could no longer withstand the extreme loads imparted to it during the final re-entry of the Columbia.

Figure 6. Likely breach location and subsequent plasma flow path

Many improvements, changes, and augmentations have been incorporated into the Space Shuttle since the loss of the Columbia. Technicians have been retrained to improve the quality of sprayed-on insulation. The External Tank has been modified to minimise the likelihood of foam shedding during ascent. Increased still and video observation has been instituted to help ensure no damage occurred during lift off, and if any damage is detected, it can be evaluated real-time. Impact detection sensors have been installed on the most susceptible wing leading edge components, the RCC panels. Likewise, impact-susceptible areas have been hardened and reinforced to help resist damage. A boom arm with a laser imaging system will allow what had been until now inaccessible and obscured areas of the Orbiters to be examined in orbit. The list goes on, but every change, improvement, or delay has all been instituted with one goal in mind: To ensure that the Space Shuttle is as safe as possible.
